Manhole Inspection Summary

Manhole # S29MM1030MH

Insp Date: **4/24/07 12:31 PM**

Location Address: **COLD SPRING LN**

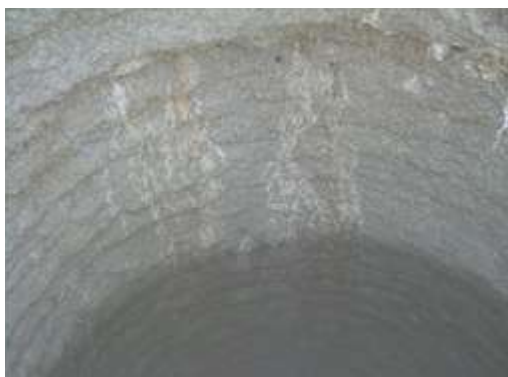
Defect

Infiltration: ☐ None ☒ **Joint** ☐ Cracks ☐ Mortar ☐ Roots ☒ **Wall**

Corbel infiltration.

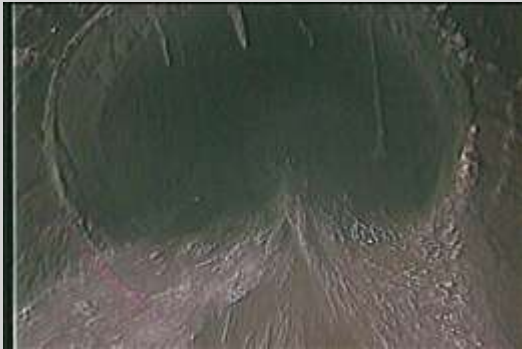
24 in. Circular Gravity Sewer Pipe Out @ 12 O'Clock

Pipe Material: **Unknown** ☒ Pipe Lined

Infiltration: **None** Pipe Seal Cond: **Unknown**

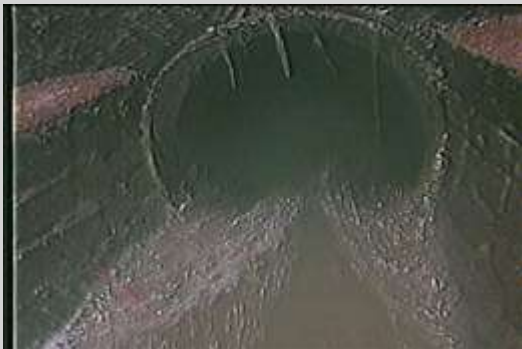
24 in. Circular Gravity Sewer Pipe In @ 5 O'Clock

Pipe Material: **Unknown** ☒ Pipe Lined

Infiltration: **None** Pipe Seal Cond: **Sound**

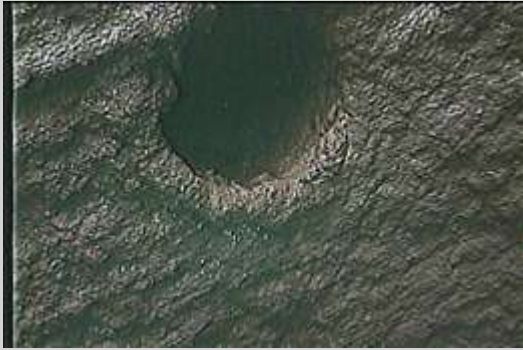
8 in. Circular Gravity Sewer

Pipe Material: **Clay** ☐ Pipe Lined

Infiltration: **None** Pipe Seal Cond: **Unknown**

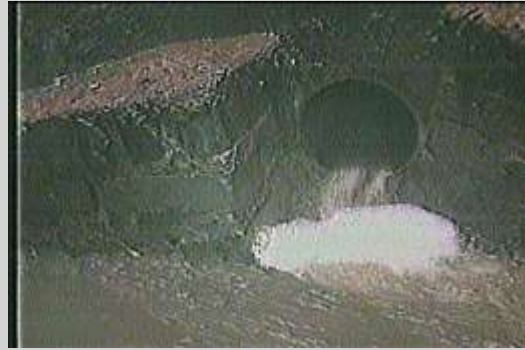
Drop In @ 9 O'Clock

Drop: **Outside** Rod and Bar

Drop Condition: **Open**
